Manhole Inspection Summary

Manhole # S59G__018MH

Insp Date: **7/23/08 10:35 AM**

Location Address: **rear 300 oldham st**

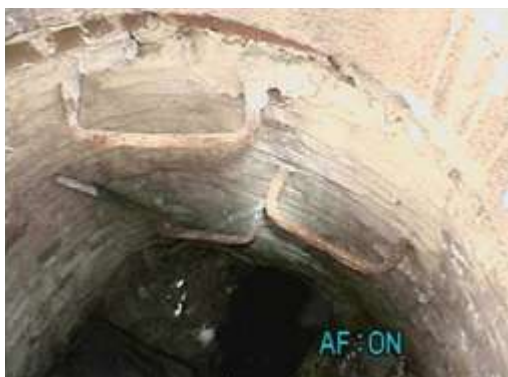
Defect 2

Count: **3** Missing: **0** ☒ **Corroded**

steps

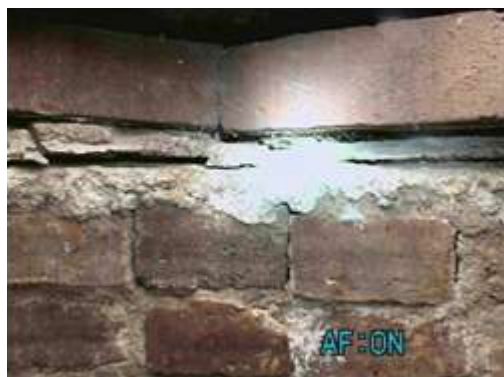
Defect 1

Condition: ☐ Sound ☐ Cracked ☐ Root Intrusion ☒ **Loose Brick** ☒ **Deteriorated**

chimney loose bricks,deteriorated,
frame adj

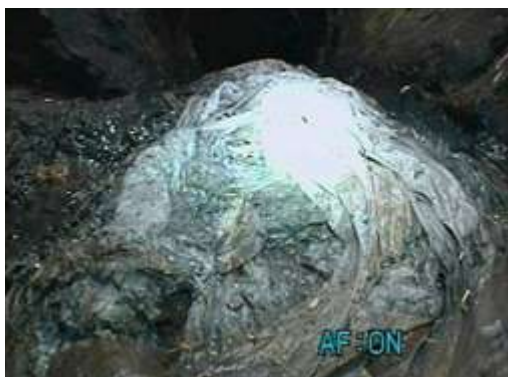
Defect 4

Condition: ☐ Sound ☐ Cracked ☐ Root Intrusion ☐ Deteriorated ☐ Leaks ☒ **Debris**

channel debris

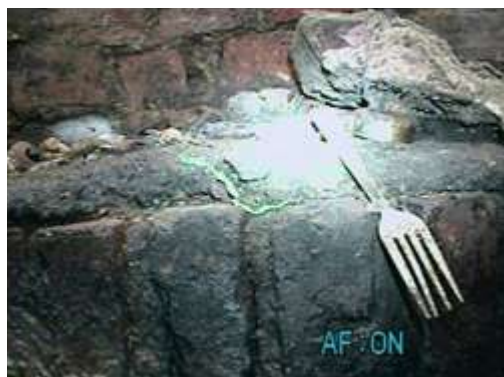
Defect 3

Condition: ☐ Sound ☐ Cracked ☐ Root Intrusion ☐ Deteriorated ☐ Leaks ☒ **Debris**

bench debris

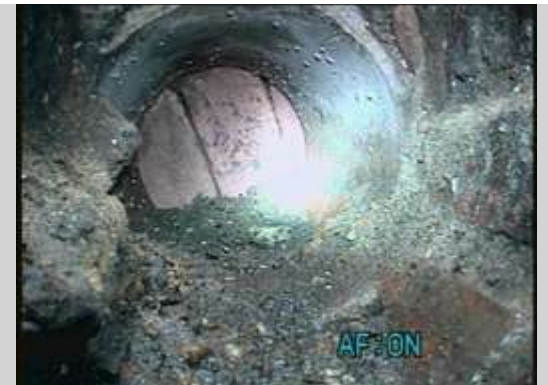
3 O'Clock Inflow

Comments **Pipe at 3 is sealed**

Connects To: **Stub connection / abandoned**
